EVALUATION OF SPRAYED-ON METALIZING FOR PRECAST PRESTRESSED CONCRETE I-BEAMS

**PHYSICAL RESEARCH REPORT NO. 141
APRIL 2002**

Illinois Department of Transportation

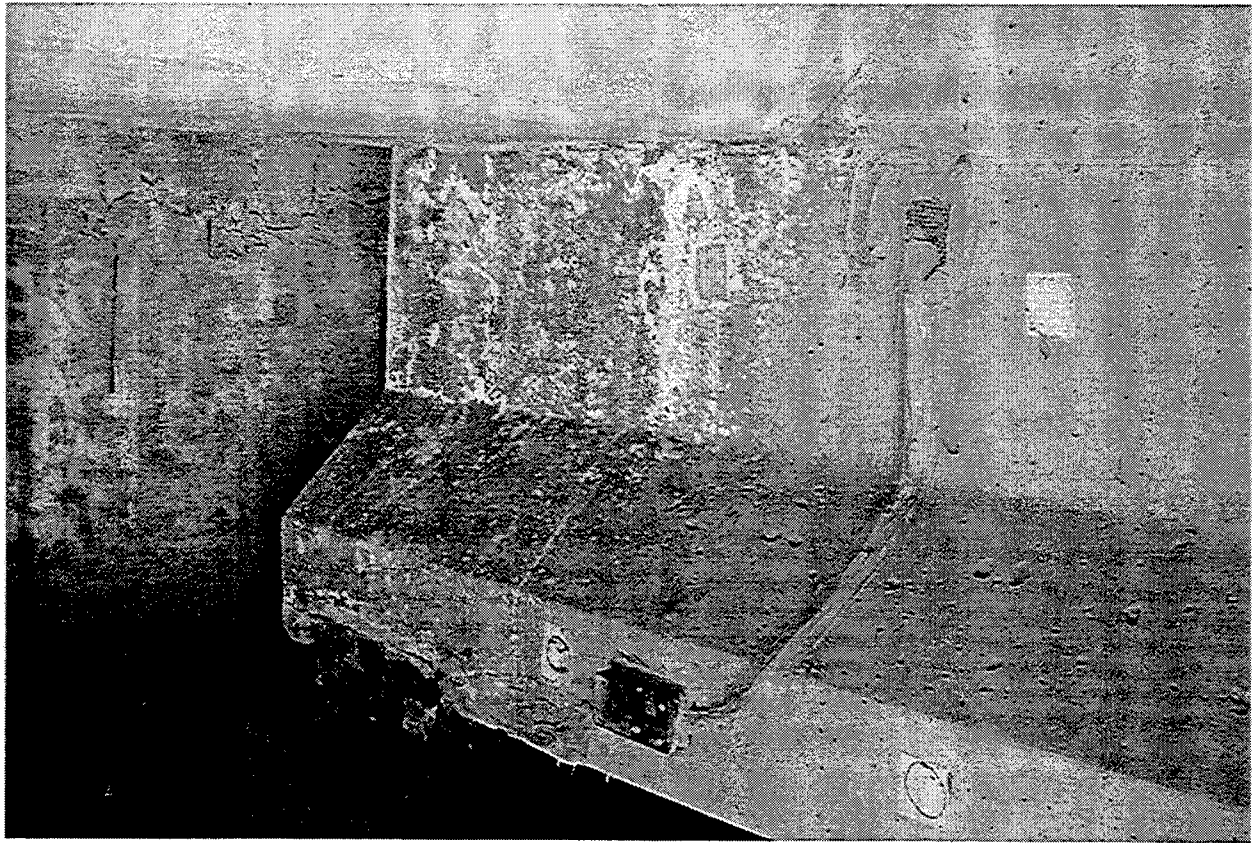
Photo 7. Beam 2 west side Zn/Al anode corrosion products.

Values for Beams 2 and 3 show a higher rate of corrosion occurring at the bottom test locations as opposed to those on top, as well as at locations closer to the end of the beams than further in the beams. This is somewhat expected since water entering the beams from leaks in the joints would collect at the exposed ends of the pre-stressing strands. More would tend to collect at the bottom of the beam than at the top as it ran down the web and collected at the exposed ends of the pre-stressing strands. Photo 7 shows evidence of zinc oxide (a corrosion product) forming on the surface of the zinc anode where water has run down the surface of the beam.

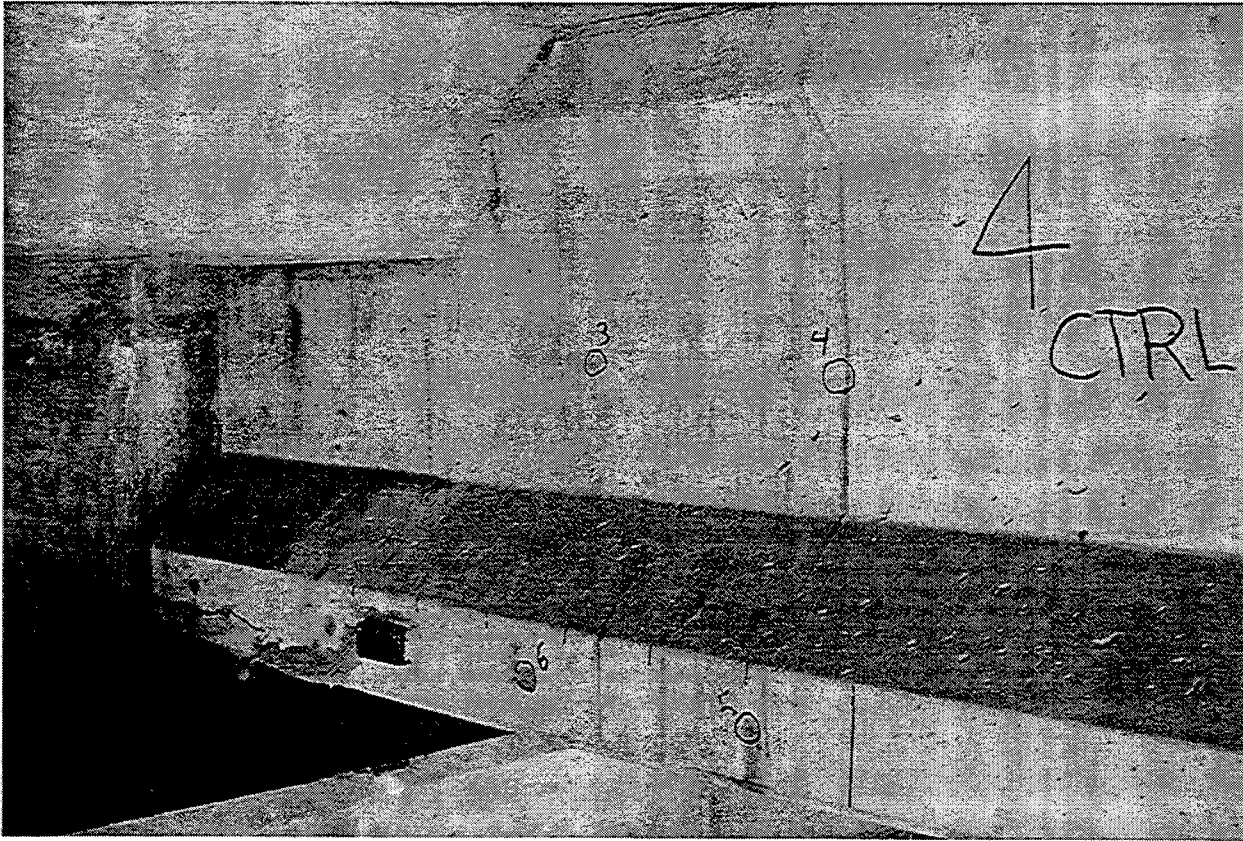
Photo 8. West side of Beam 4. Little evidence of water running down the face of the beam.

Beams 4 and 5 (control beams) show small changes in the corrosion potentials compared to the other beams, possibly due to the intact deck joint preventing water from migrating into the beams. The two beams show the least amount change in corrosion potentials compared to the treated beams. Photo 8 shows evidence of very little water running down the face of beam 4.

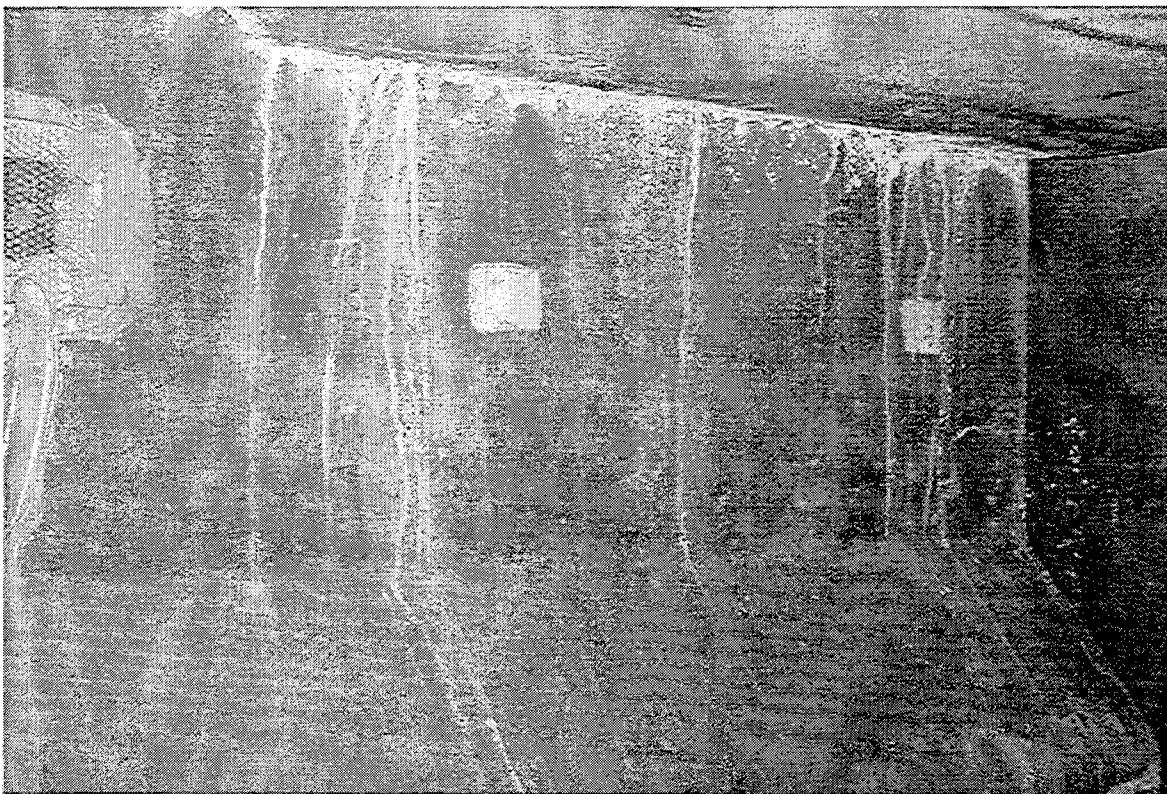
Photo 9. Beam 10, east side. Corrosion products forming from leaks in deck or at joint.

Beam 10 shows corrosion potentials which are somewhat higher than the control beams, possibly due to leaking joints. Photo 9 shows the corrosion products. Beam 12 shows corrosion potentials much lower than the control beams. These values, again are somewhat unrealistic for a fascia beam exposed to rain.

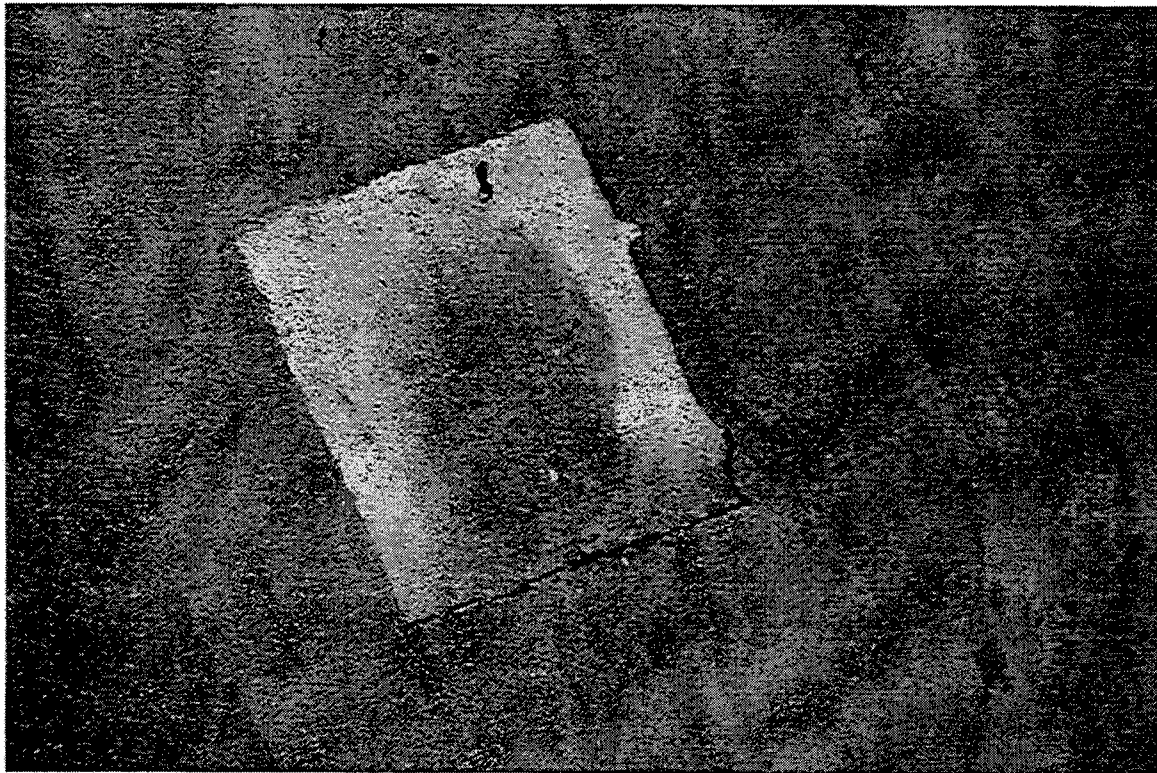
Photo 10. Water short across concrete to anode.

Beams 10, 11, and 12 were treated with an anode composed of 85% zinc and 15% aluminum. Beam 11 shows unrealistically high readings. This may be due to active corrosion occurring at the strands or may be in part due to an electrical short occurring between the zinc anode and the copper/copper sulfate half cell due to a small amount of water applied to the surface of the concrete per ASTM C-876. This is similar to what may have occurred at test site A on Beam 1.

Evaluation of the three different types of "spray on" anodes for galvanic cathodic protection indicate that the systems do not offer any improved amount of protection to the pre-stressing strands when compared to beams that were not treated. Results from the corrosion potential surveys indicate that the systems are not protecting the steel. It appears that the anodes do not develop enough current necessary to drive the ion exchange to arrest the corrosion process. An additional survey is proposed for spring of 2002 to evaluate the anode performance. Several environmental factors as well as equipment factors which may have affected the test results will be evaluated. A main concern is the effect of water, used to moisten the surface of the concrete, bridging across the anode to form a localized short in the system. This will be addressed by using a highly conductive multi-purpose electrolyte gel to ensure conductivity. Additionally, a smaller diameter copper-copper sulfate half-cell will be evaluated to reduce the chances of bridging across the anode.
